Analysis of non-destructive testing methods for assessing structural integrity in distressed building (Cases Study of Lagos Island, Lagos State, Nigeria)

World Journal of Advanced Engineering Technology and Sciences, 2025, 15(03), 663-672

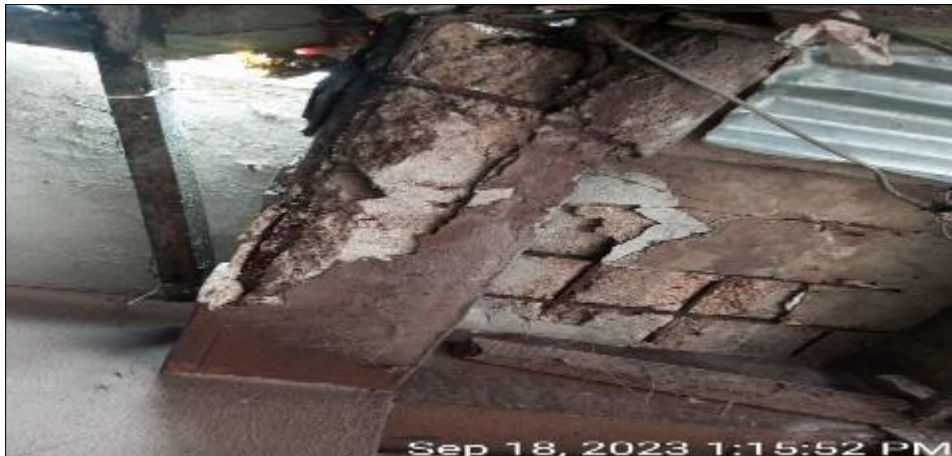
Figure 4 Distressed Building with Concrete Spalling off from Slab and Beam

During the visual inspection of the distressed buildings, several observations were made, some interior and exterior walls of 85% buildings tested showed multiple cracks and fissures, some of which appeared to be quite deep. The cracks were observed to be more severe at the corners and edges of 85% of buildings tested. Ninety percentage (90%) of buildings tested also displayed signs of water damage, with discoloration and staining visible on several of the walls. In some areas, the painting finish of the exterior walls had begun to peel away, revealing the underlying block work. Furthermore, several windows were found to be broken or missing, and the roof showed signs of wear and tear, with several shingles missing or damaged. These observations indicate that 85% of buildings are in a state of disrepair, and further investigation is necessary to assess its structural integrity which result in the use if rebound hammer and ultrasonic pulse velocity.

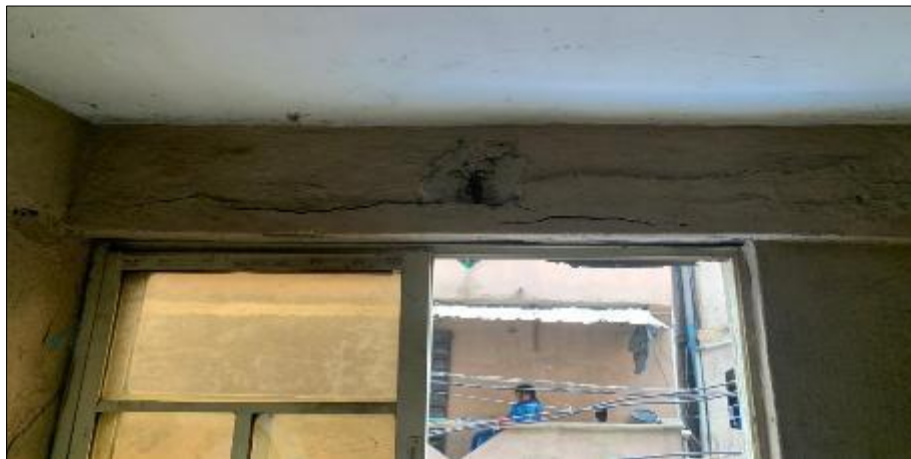
Figure 5 Building Showing Different Cracks Pattern (Source Field)

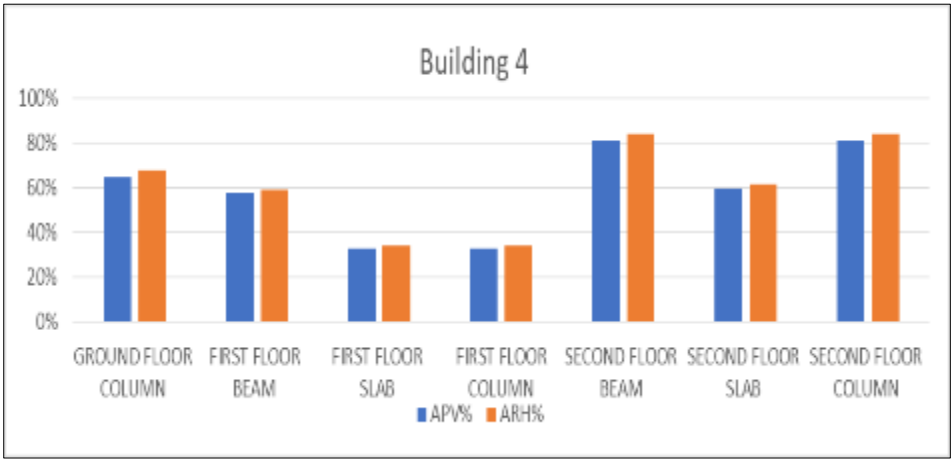
Figure 9 shows the summary of all test results. Rebound hammer test revealed that 68% of ground floor columns tested has strength above 25N/mm² and such were rated good. Likewise, 34% on the first floor columns are remarked delaminated as they have strength below 25N/mm². UPV test revealed that 65% of ground floor columns and 33% of first floor columns tested have strength above 25N/mm² and such were rated poor.

Figure 9 Summary of tests for building 4
