# Assessment of crumb rubber as a partial substitute with quarry dust for the production interlocking paving stone

World Journal of Advanced Engineering Technology and Sciences, 2025, 15(02), 231-239

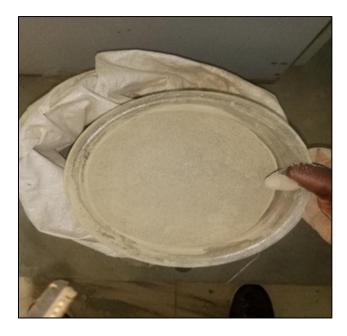
The materials used in this study were sourced from a location in Ibadan, Oyo State. The cement and lubricating oil were purchased from a local distributor. Quarry dust (stone dust) was obtained from a granite quarry in Lagos, while the potable water used for mixing was drawn from the borehole at the Engineering Workshop, Ajayi Crowther University. The crumb rubber, derived from discarded vehicle tires, was sourced from local vulcanizers and tire recycling centers in Gate, Ibadan, Oyo State. The collected rubber waste was then processed into fine particles through mechanical grinding and sieve as shown in figure 1

Figure 1 Processed powdered crumb rubber

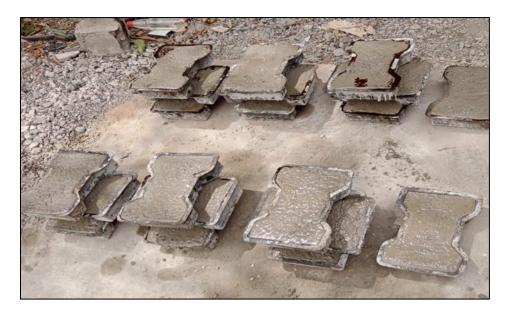
After obtaining the weight of cement, crumb rubber and stone dust required, mixing was done manually by adding water to the constituents and thoroughly mixed. Proportions of mix is cast and placed into the moulds with the aid of the hand trowel. The cast products are then left for 24 hours to set properly in Figure 2 before they were removed from the mould. The interlocks were cured by placing them in a curing tank for 7, 14, 21 and 28 days to attain adequate strength and the physical strength were carried out on the interlocks.

Figure 2 Interlocking paving stones
